TWR-50290

Thiokol/Wasatch Installation Evaluation of the Redesigned Field Joint Protection System (Concepts 1 and 1C) Final Test Report

January 1990

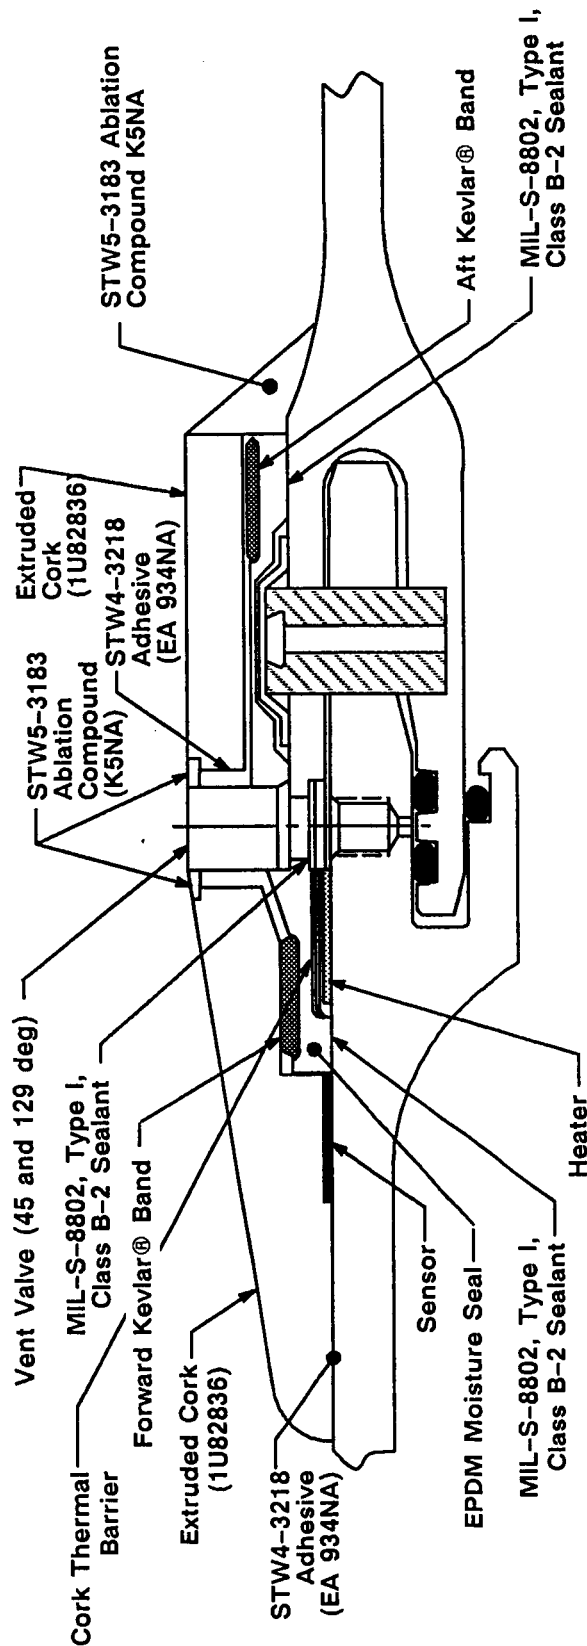
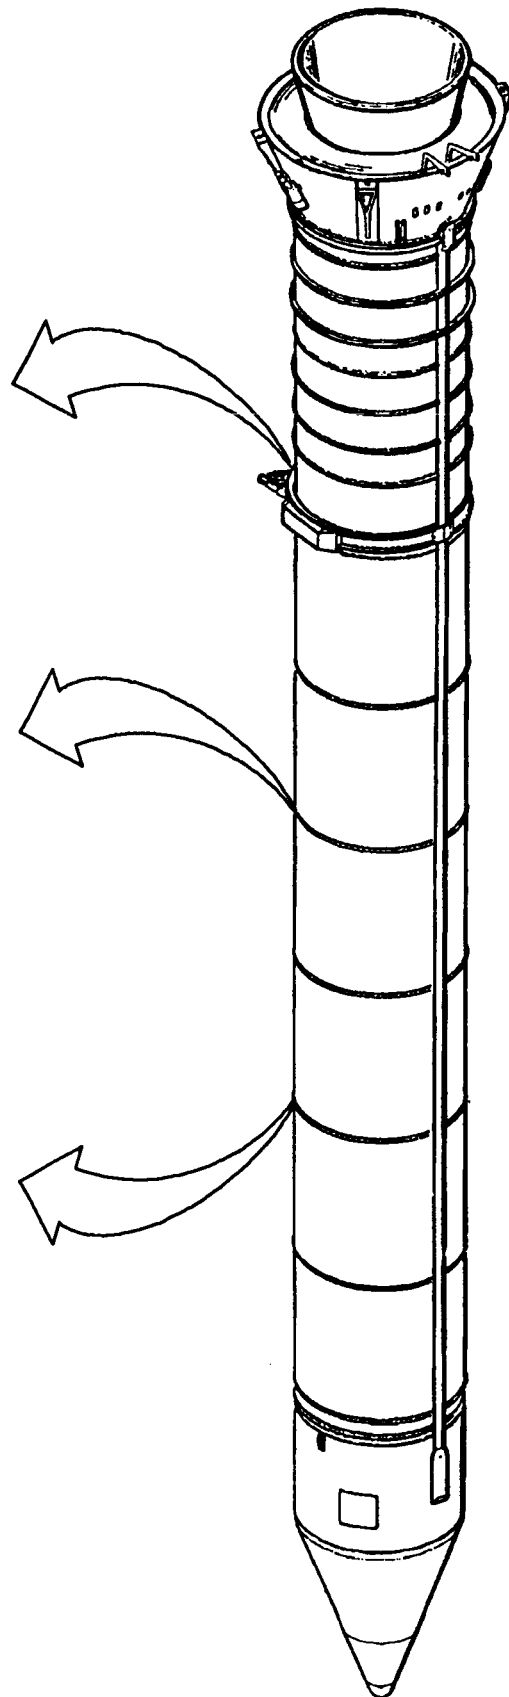
The FJPS is installed on redesigned solid rocket motor (RSRM) field joints to prevent rain intrusion into the joints and to maintain the joint temperature sensors between 85° and 122°F while the boosters are on the launch pad. The FJPS is being redesigned to reduce installation timelines at KSC and to simplify or eliminate installation processing problems related to the present design of an ethylene-propylene-diene-monomer (EPDM) moisture seal/extruded cork combination (Figure 1).

Figure 1. Current Design of the FJPS (EPDM moisture seal/extruded cork)

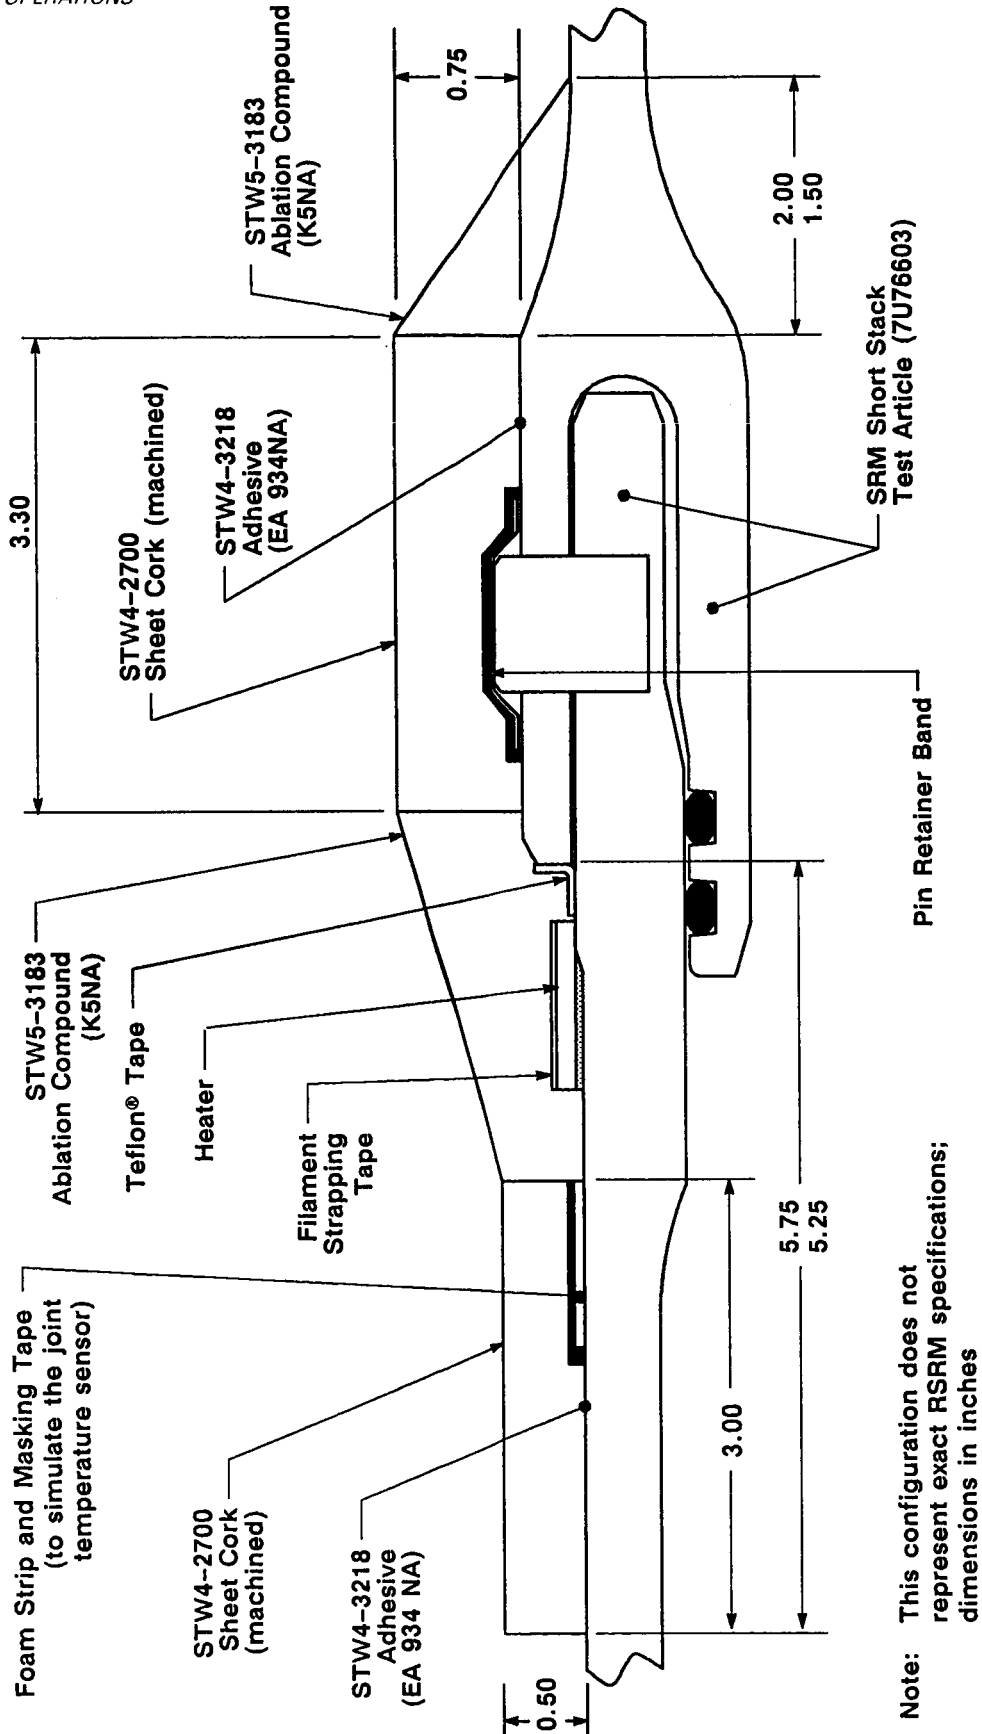
Concept 1 (double cork band design) of the redesigned FJPS proposals utilizes two cork bands with STW5-3183 ablation compound (K5NA) applied between them and to the bottom edge of the aft cork band (Figure 2). The cork bands are bonded over the joint pin retainer band area and over the joint temperature sensor area. For this evaluation, only the aft cork band was installed. The aft cork sections were machined to fit against the pin retainer band (nominal tolerance). Three types of adhesive (to bond the aft cork band) were evaluated: STW4-3218 adhesive (EA 934NA), EA 934NA with Cab-O-Sil filler (2.5 percent by weight), and an MSFC-recommended adhesive (3M Scotch-Weld Brand Epoxy Adhesive, EC 2216 B/A Gray) with Cab-O-Sil filler (3.0 percent by weight).

Note: This configuration does not represent exact RSRM specifications; dimensions in inches

Figure 2. Concept 1 of the Redesigned FJPS—Installation Evaluation

The installation of Concept 1 aft cork band sections was then performed, to compare three adhesives (Figure 2). The three adhesives evaluated were: EA 934NA adhesive, EA 934NA adhesive with Cab-O-Sil filler (2.5 percent by weight), and EC 2216 adhesive with Cab-O-Sil filler (3.0 percent by weight). Personnel applying the adhesives preferred the workability of the EC 2216 adhesive with Cab-O-Sil best, then the EA 934NA adhesive with Cab-O-Sil, and lastly the EA 934NA adhesive without filler. Removal of the cork sections that were installed over Teflon[®] tape revealed bubbles in the cured EC 2216 adhesive. The EA 934NA adhesive with Cab-O-Sil bondline had a few small pits. The EA 934NA adhesive bondline had no visible voids and was thinner than the other two adhesive bondlines. Pull test results indicated that the pin retainer band surface may have been contaminated for the EA 934NA adhesive installation. Cohesive cork failures in the other pull tests indicated adequate adhesion for each adhesive.

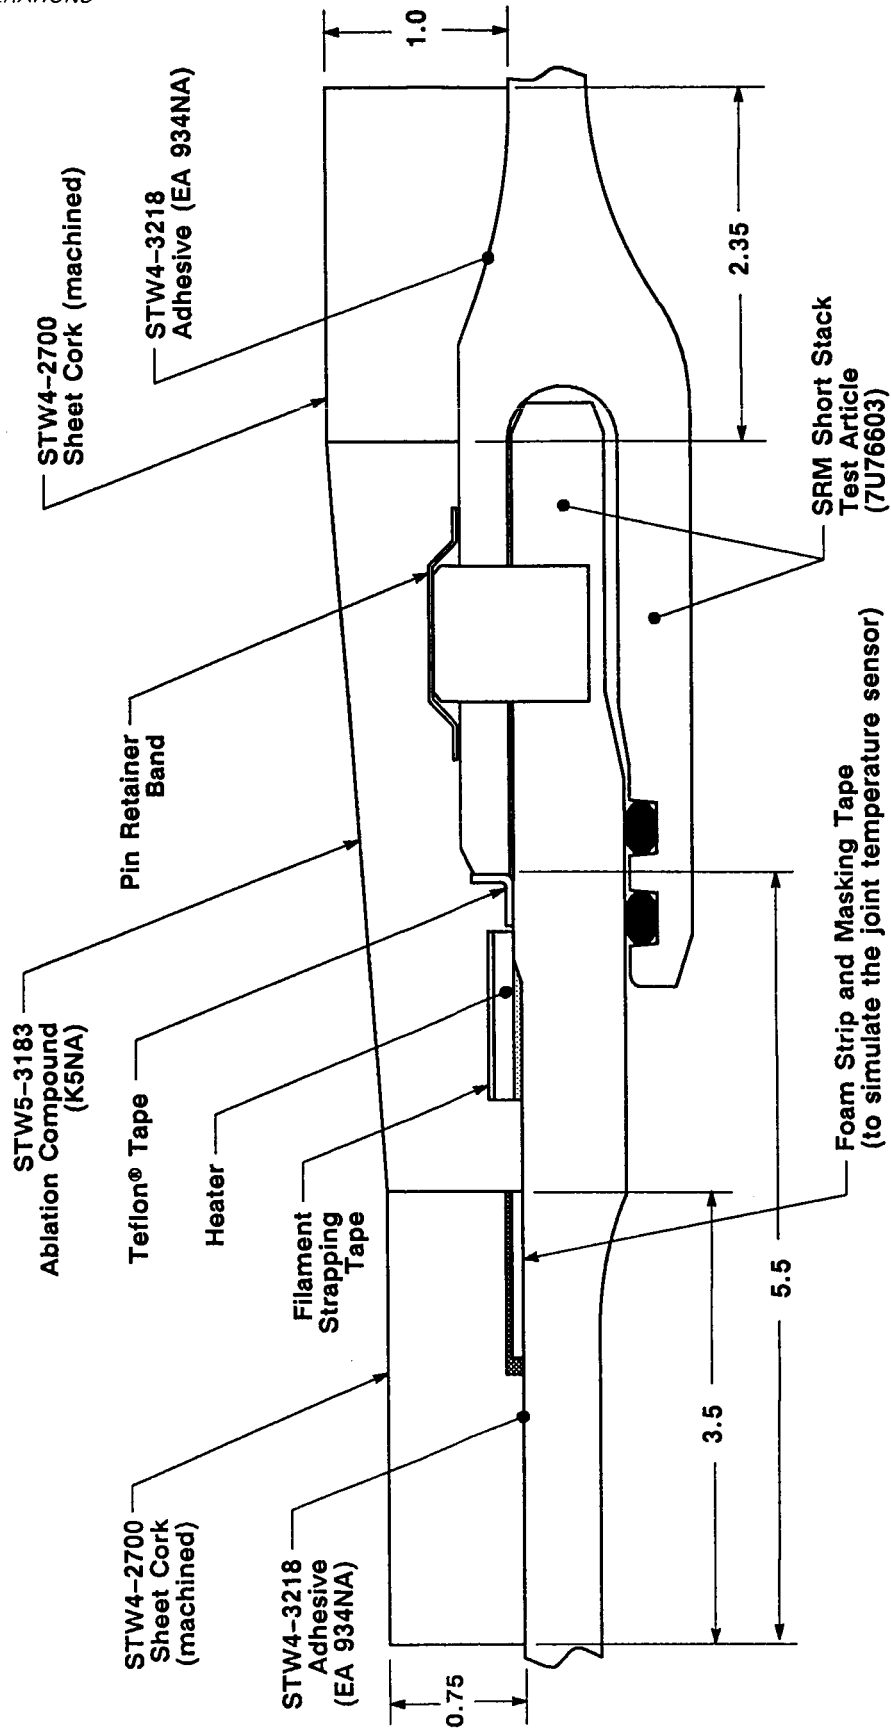
The Concept 1C configuration (double cork band/K5NA design) also consists of two cork bands with K5NA applied between them (Figure 3). The aft cork band location extends from the

Note: This configuration does not represent exact RSRM specifications; dimensions in inches

Figure 3. Concept 1C of the Redesigned FJPS—Installation Evaluation

outer clevis leg transition area to just aft of the pin retainer band. The forward cork band is located over the joint temperature sensor. EA 934NA adhesive was used to bond the cork bands.

The Concept 1C configuration was installed first (Figure 3). The forward and aft cork sections were installed and held in place with steel strapping bands. The pressure applied by the steel strapping bands was not enough to keep the cork butt joints pressed firmly against the case. As a result, plastic shims were placed between the steel and cork bands over the butt joints. With the use of plastic shims, adhesive squeezeout occurred across the entire cork/case bondline. During K5NA application, it was difficult to keep the K5NA from slumping and separating from the forward cork band. The K5NA slumped during cure and became unbonded at several areas on the forward cork band bondline. Bondline bubble voids occurred in the case-Teflon[®] tape/aft cork band bondline. The forward cork band/case-Teflon[®] tape bondline was smooth and uniform. The presence of cork/case adhesive bondline voids could have been caused by separations between the cork and case during the installation process. Pull test results showed that pressure on the forward cork band may not have been adequate to result in a consistent bondline.

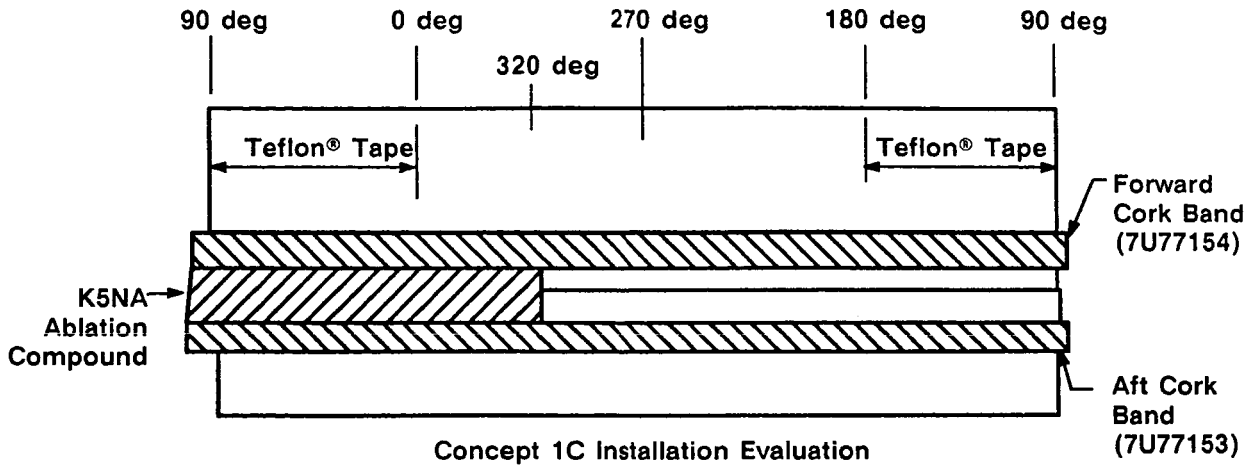
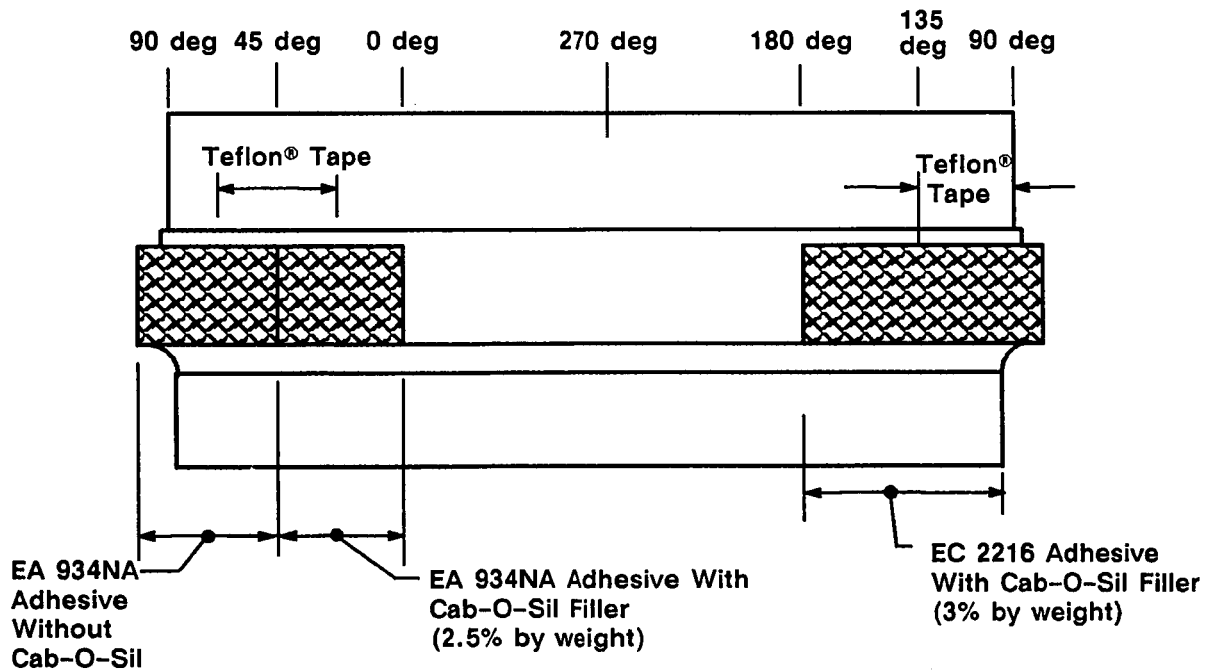
Concept 1 Adhesive Evaluation—Aft Cork Band (7U77128-01)

Figure 4. Concept 1 and 1C Installation Flat Pattern

The Concept 1C (double cork band/K5NA design) installation evaluation demonstrated the redesigned FJPS configuration, which consists of two cork bands with K5NA applied between them (Figure 3). The assembly was installed following the configuration of drawing TUL-16825. The 4-ft-long aft sheet cork sections were machined to fit the contour of the outer clevis leg transition area. The 4-ft-long forward sheet cork sections were machined to fit directly over the joint temperature sensor. The cork bands of the Concept 1C configuration were installed around the entire joint, and the K5NA was installed over 130 deg only (Figure 4).

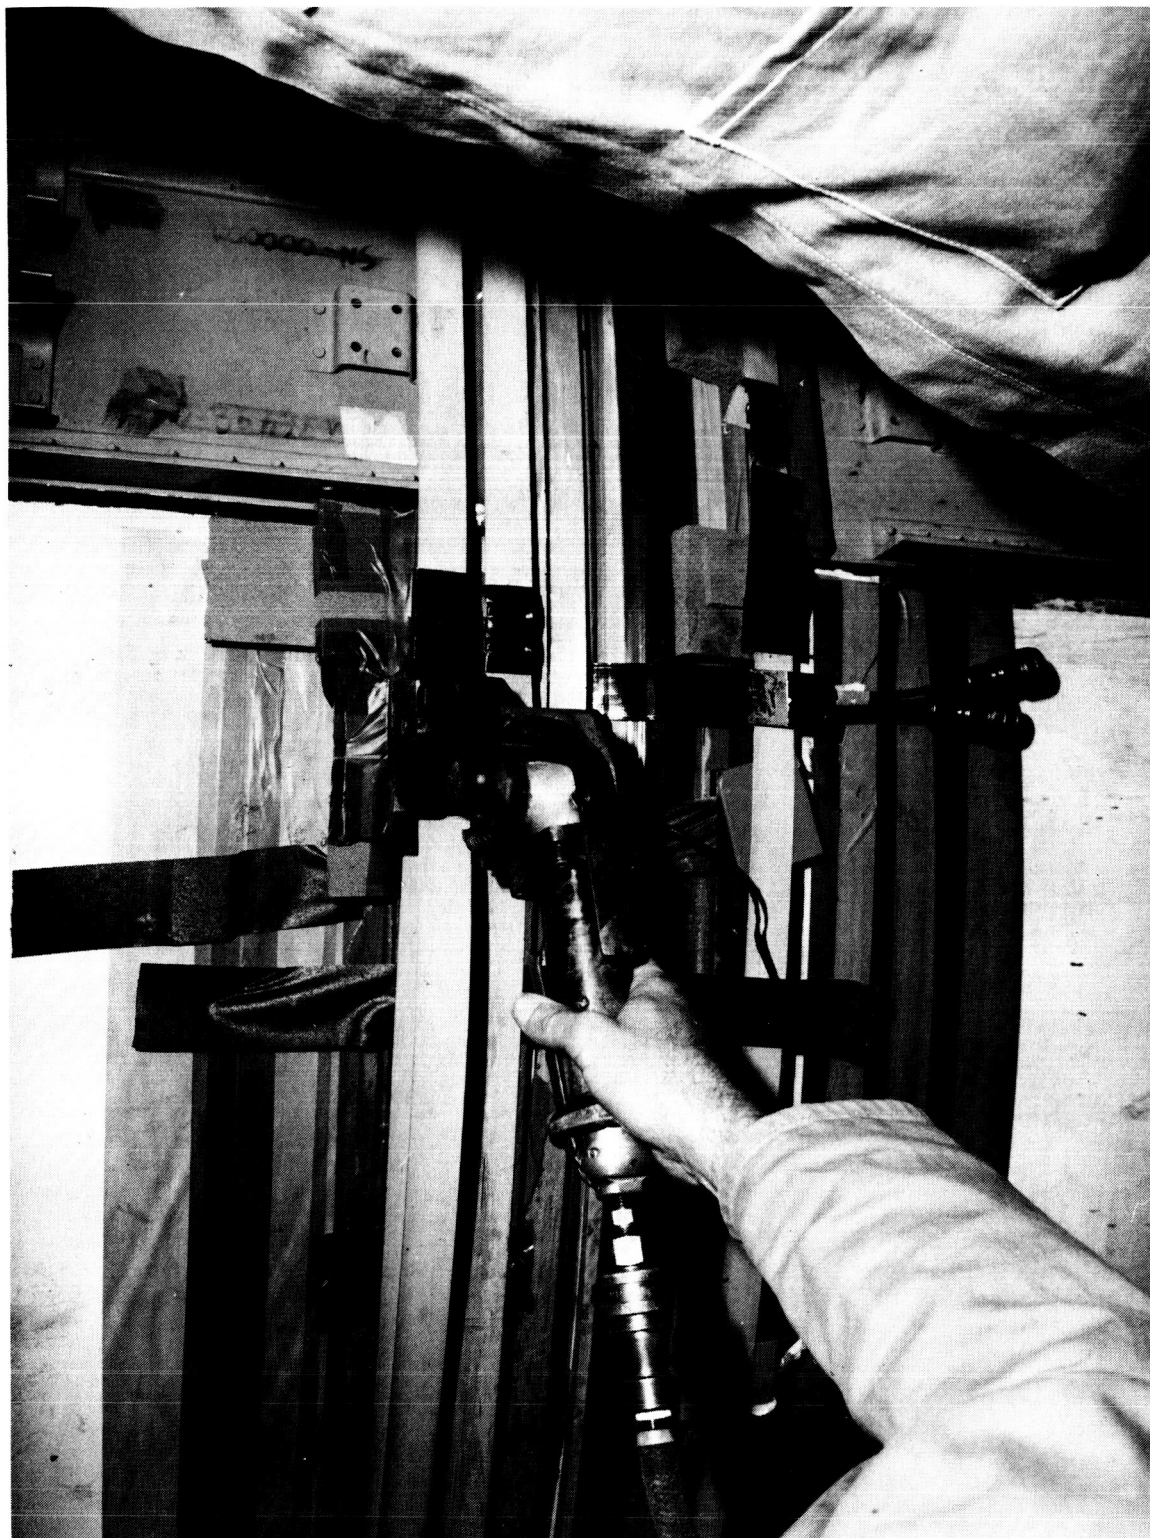
Figure 5. Concept 1C Forward Cork Band--Steel Strapping Band Tensioning Processes

The forward cork band installation procedures were similar to the installation procedures for the aft cork band. Accurate fitting of the forward cork band over the foam strip (simulating the joint temperature sensor) was difficult; a guide for the top of the forward cork band would have made the installation easier. Since the two steel strapping bands had to go over the systems tunnel floor plates, cork blocks were placed between the sheet cork and raised steel strapping bands; this assured pressure on the sheet cork bonded near the systems tunnel. The cork butt joints were not firmly pressed against the case, and again, plastic shims were used to force the cork against the case.

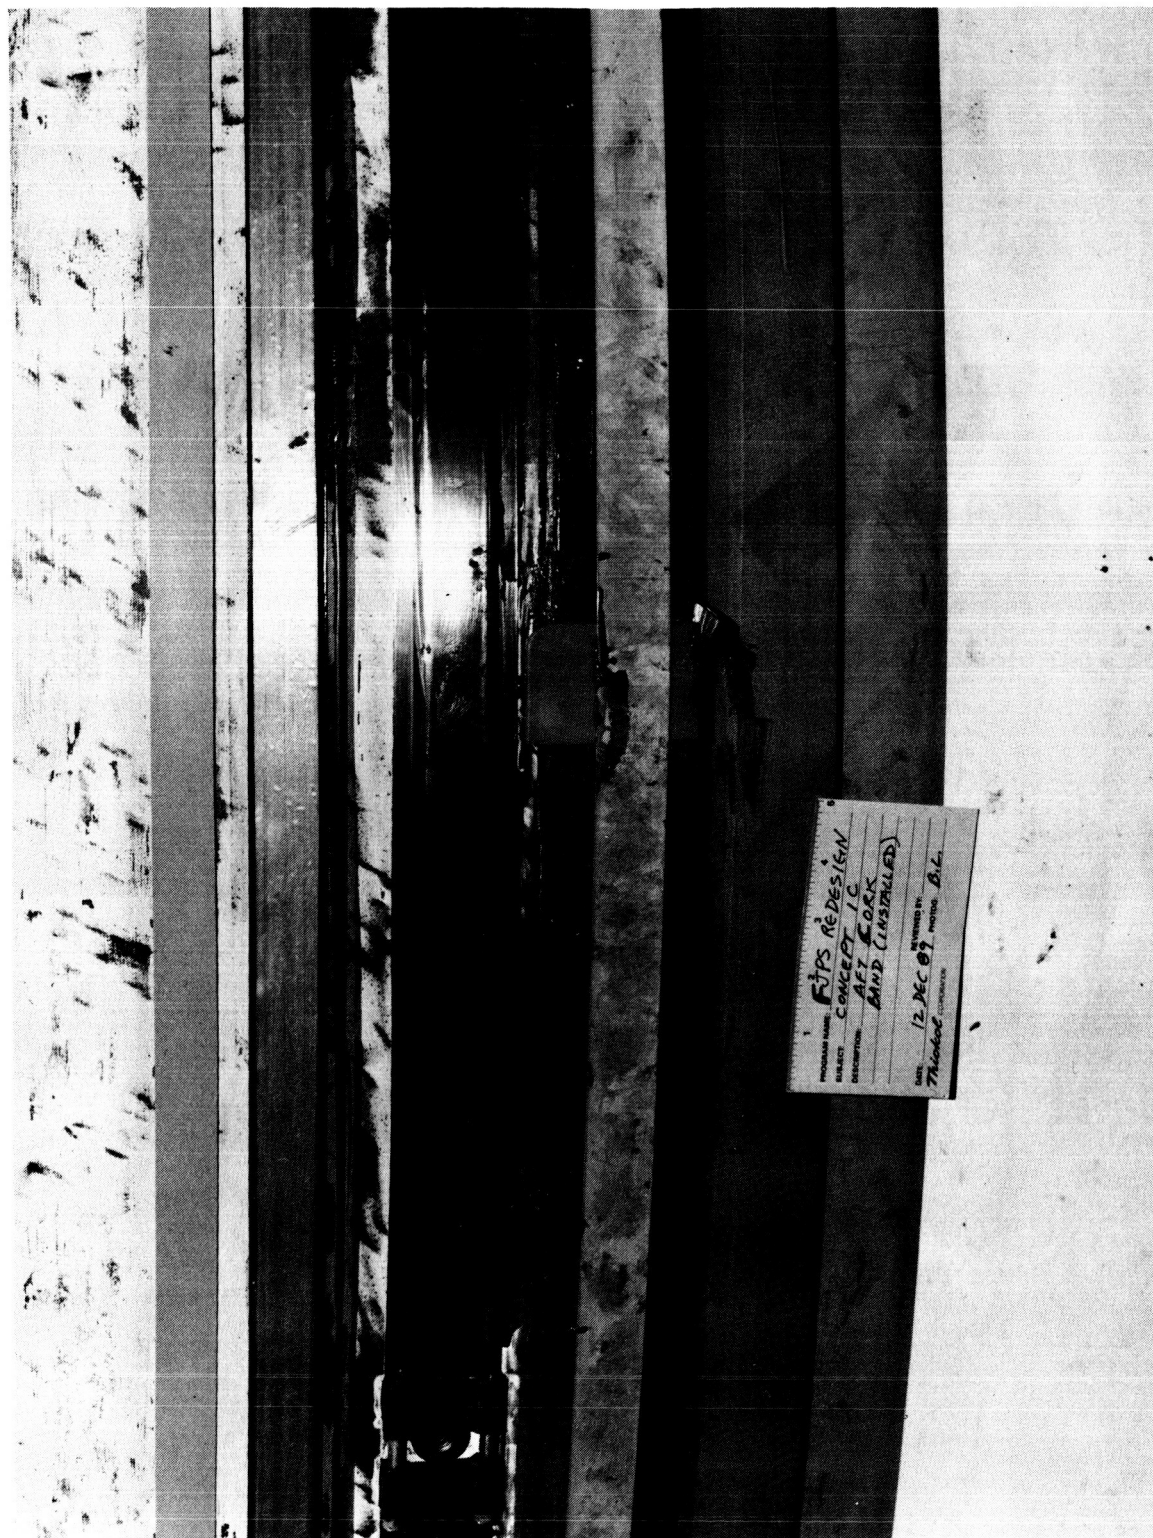
The pressure applied by the steel strapping band was not enough to keep the aft cork butt joints pressed firmly against the case. As a result, plastic shims were placed between the steel and cork bands over the butt joints (Figure 6). With the use of plastic shims, adhesive squeezeout occurred across the entire cork/case bondline. The following changes may have improved the aft cork band installation:

Figure 6. Concept 1C Aft Cork Band--Plastic Shim at Cork Butt Joint

- A. Using two steel strapping bands or one wider steel strapping band.
- B. Tensioning the steel strapping band(s) at more than one location.
- C. Using sections of cork that are longer than 4 ft to reduce the amount of butt-joint bondline separations.

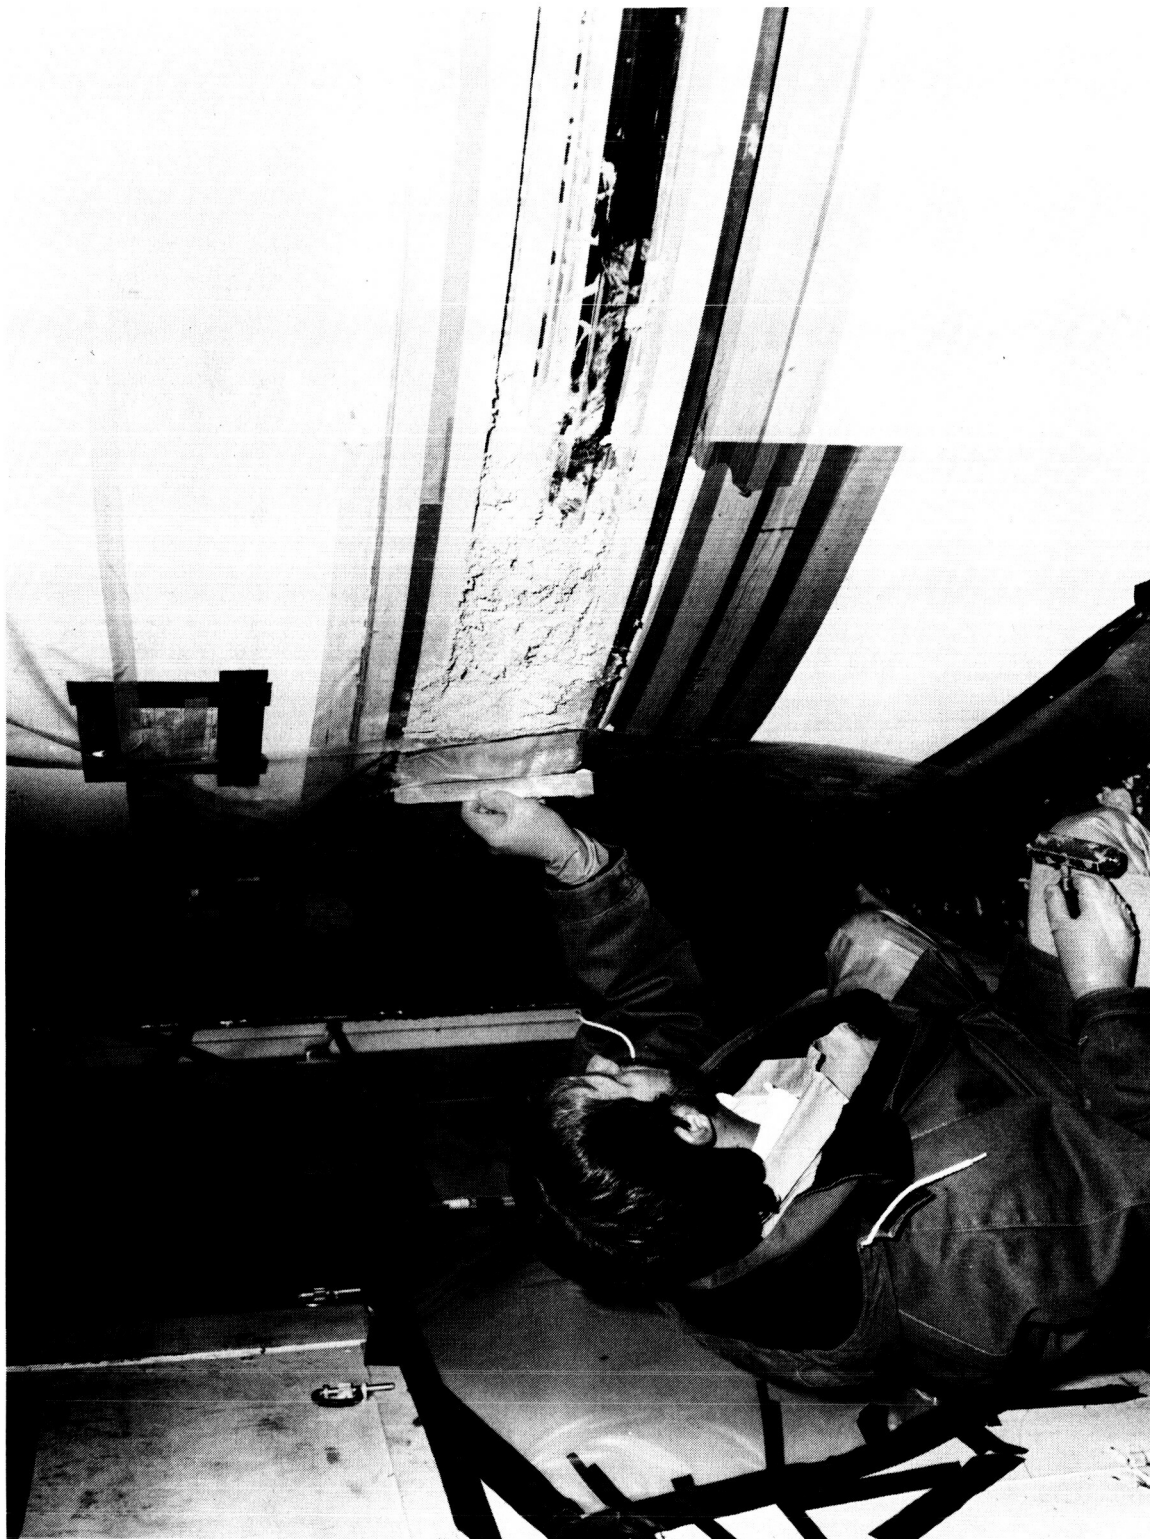
Installation/Material. Installation of the K5NA began 4 hr after the completion of cork installation. The three steel strapping bands were removed during the K5NA preparation process. Masking tape was applied to the top edges of the cork bands near the K5NA bondline for removal after the K5NA was installed. All of the case/cork/Teflon[®] tape bondline surfaces were wetted with a thin coat of K5NA just prior to the application of large amounts of K5NA. The preferred application method consisted of one person firmly applying K5NA to the desired area, another person sculpting the surface with a plastic spatula or a piece of Teflon[®]-taped cork, and a third person finishing the surface with a small Teflon[®]-coated rolling pin (Figure 7). The rolling pin was applied directly to the K5NA surface and was frequently cleaned with solvent. Most of the K5NA surface was covered with antistatic plastic film during the rolling pin process and during cure.

During K5NA application, it was difficult to keep the K5NA from slumping and separating from the forward cork band. Six batches of K5NA, all from the same lot, were installed over the 130-deg area. Only one of the six batches of K5NA had the proper viscosity; the other five mixes were too thin and thus difficult to apply. Current requirements for ablation compound allow extreme variation in cork particle volume density versus weight.

Figure 7. Concept 1C--Ablation Compound Installation

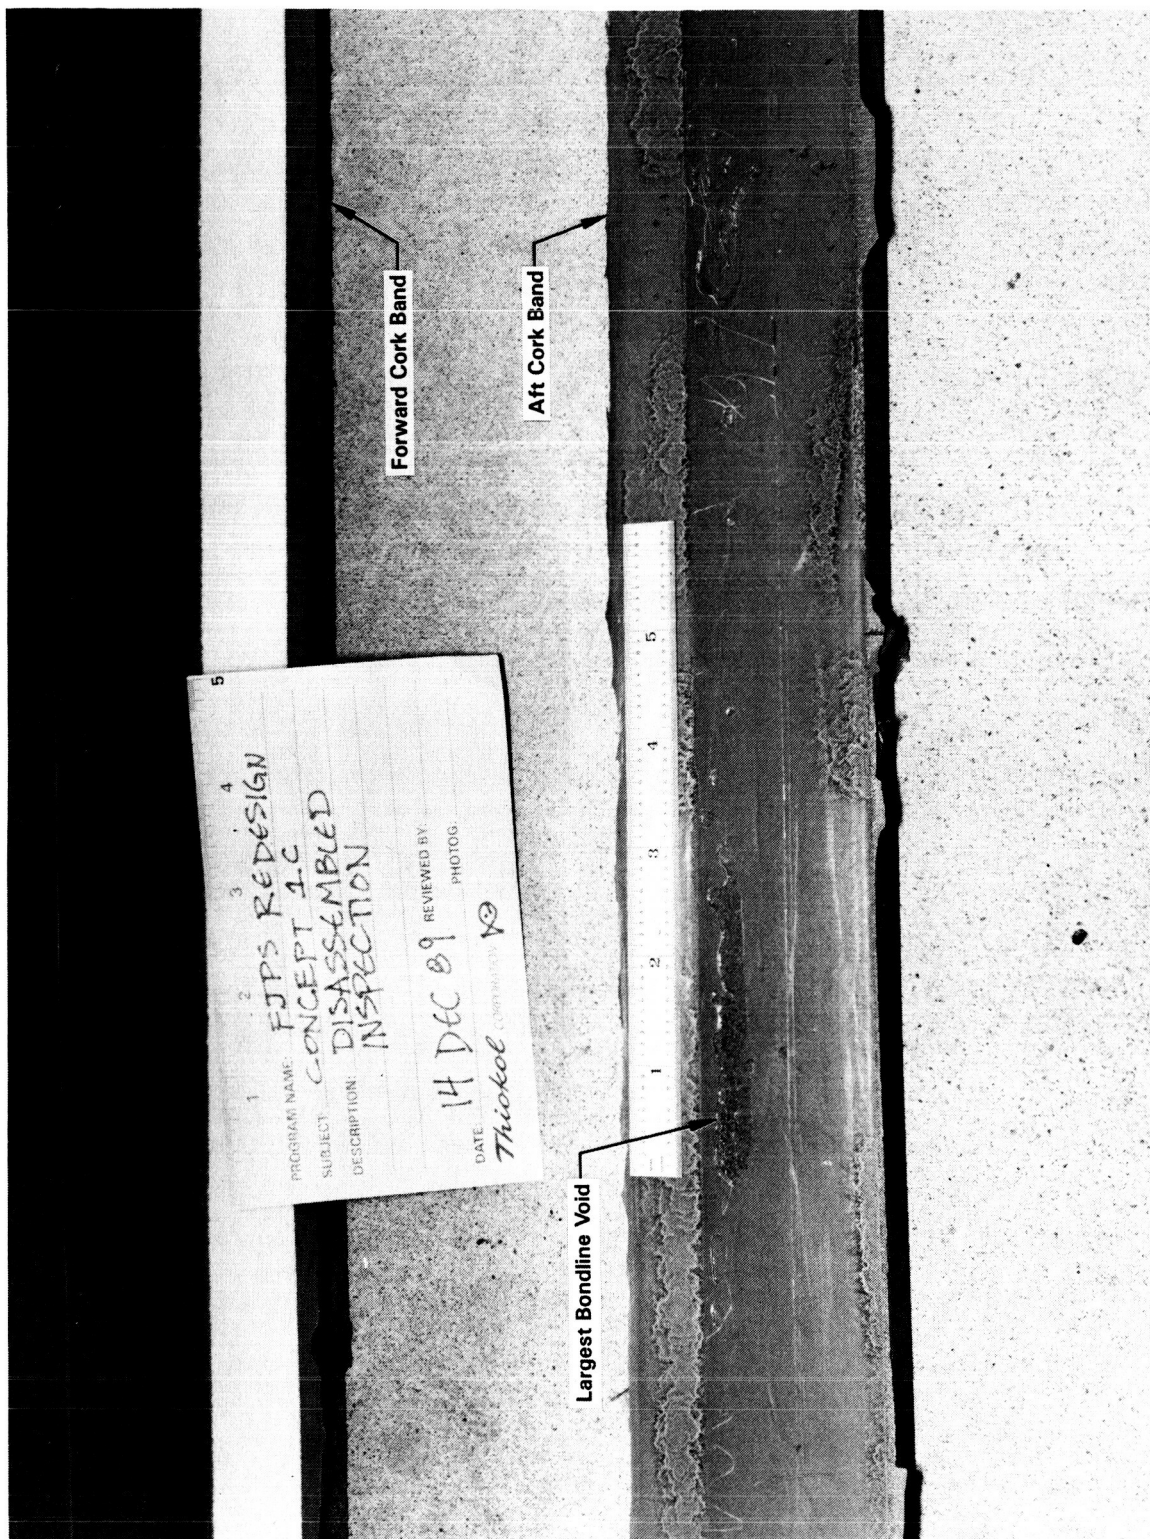
Bondline bubble voids occurred in the case-Teflon[®] tape/aft cork band bondline (Figure 8). These most likely occurred because the cork band slid aft during cure after the cork guide was removed. During future installations, the aft cork guide should remain in place until the aft cork has cured. The largest of the voids was approximately 3.0 by 0.5 by 0.0625 inches. The forward cork band/case-Teflon[®] tape bondline was smooth and uniform. The presence of cork/case adhesive bondline voids could have been caused by separations between the cork and case during the installation process. After the adhesive-coated cork was initially fitted against the case, it may have separated at the cork section ends and other areas prior to the tightening of the steel strapping bands.

Figure 8. Concept 1C--EA 934NA Adhesive Bondlines

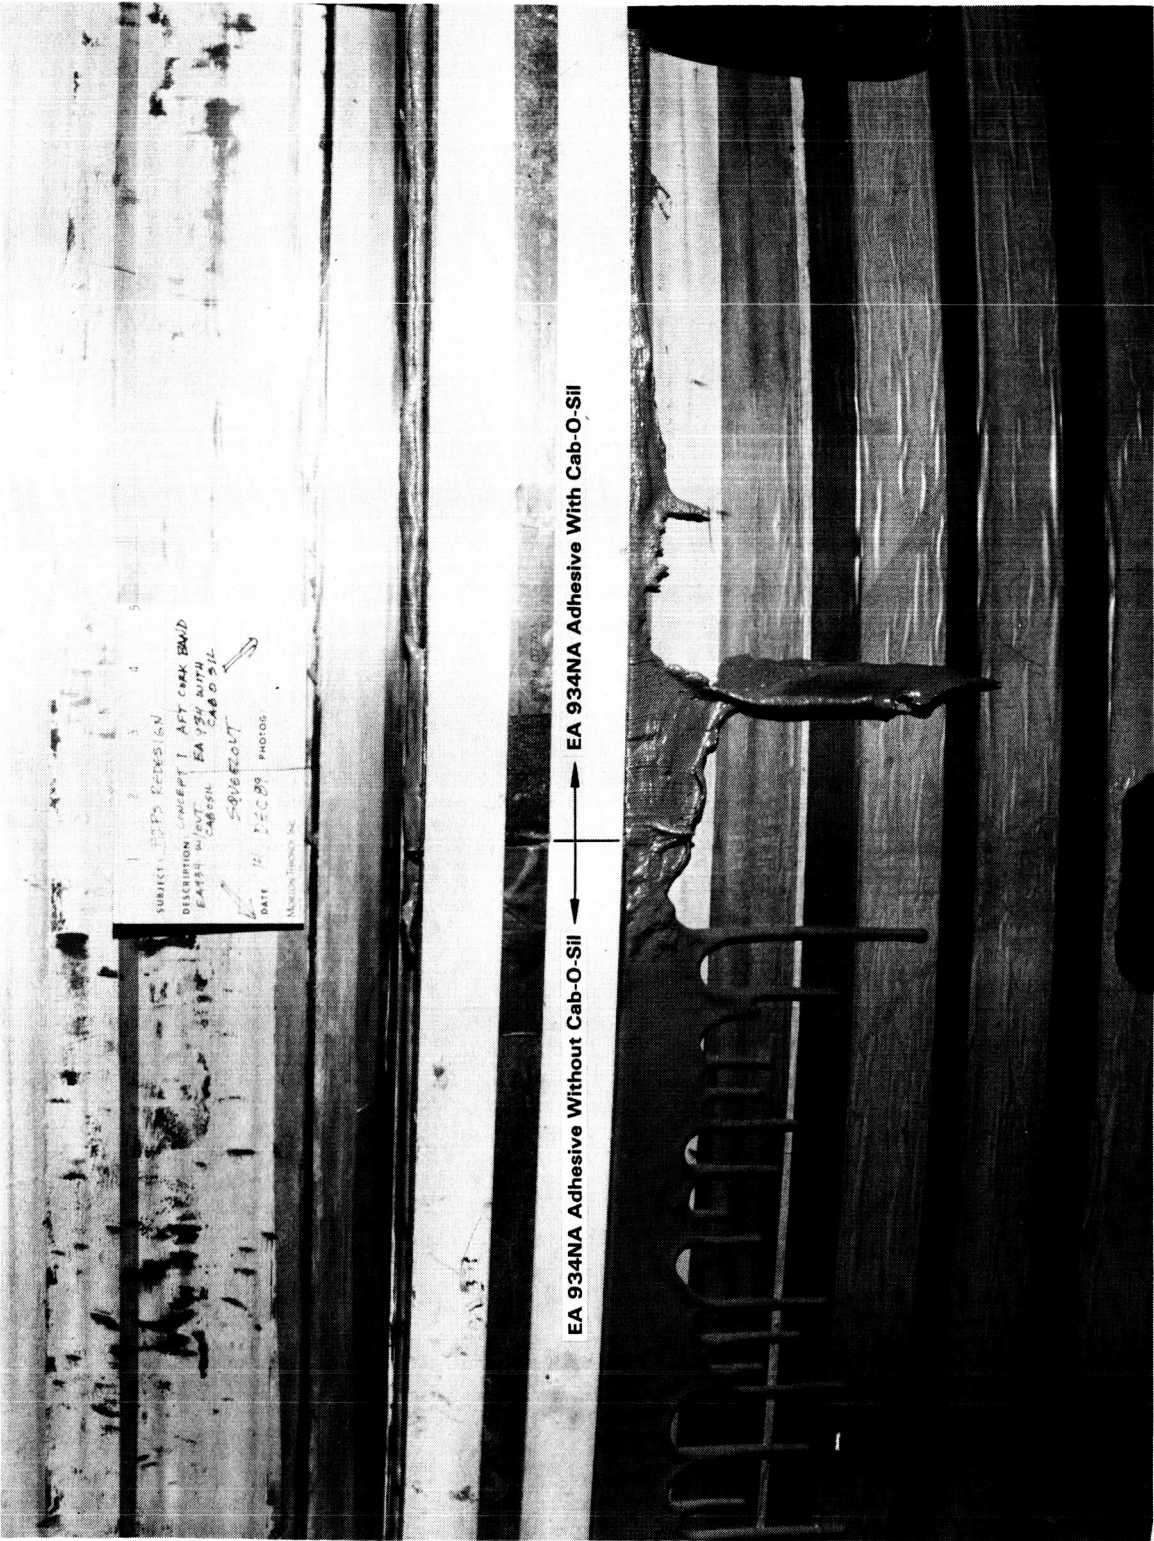
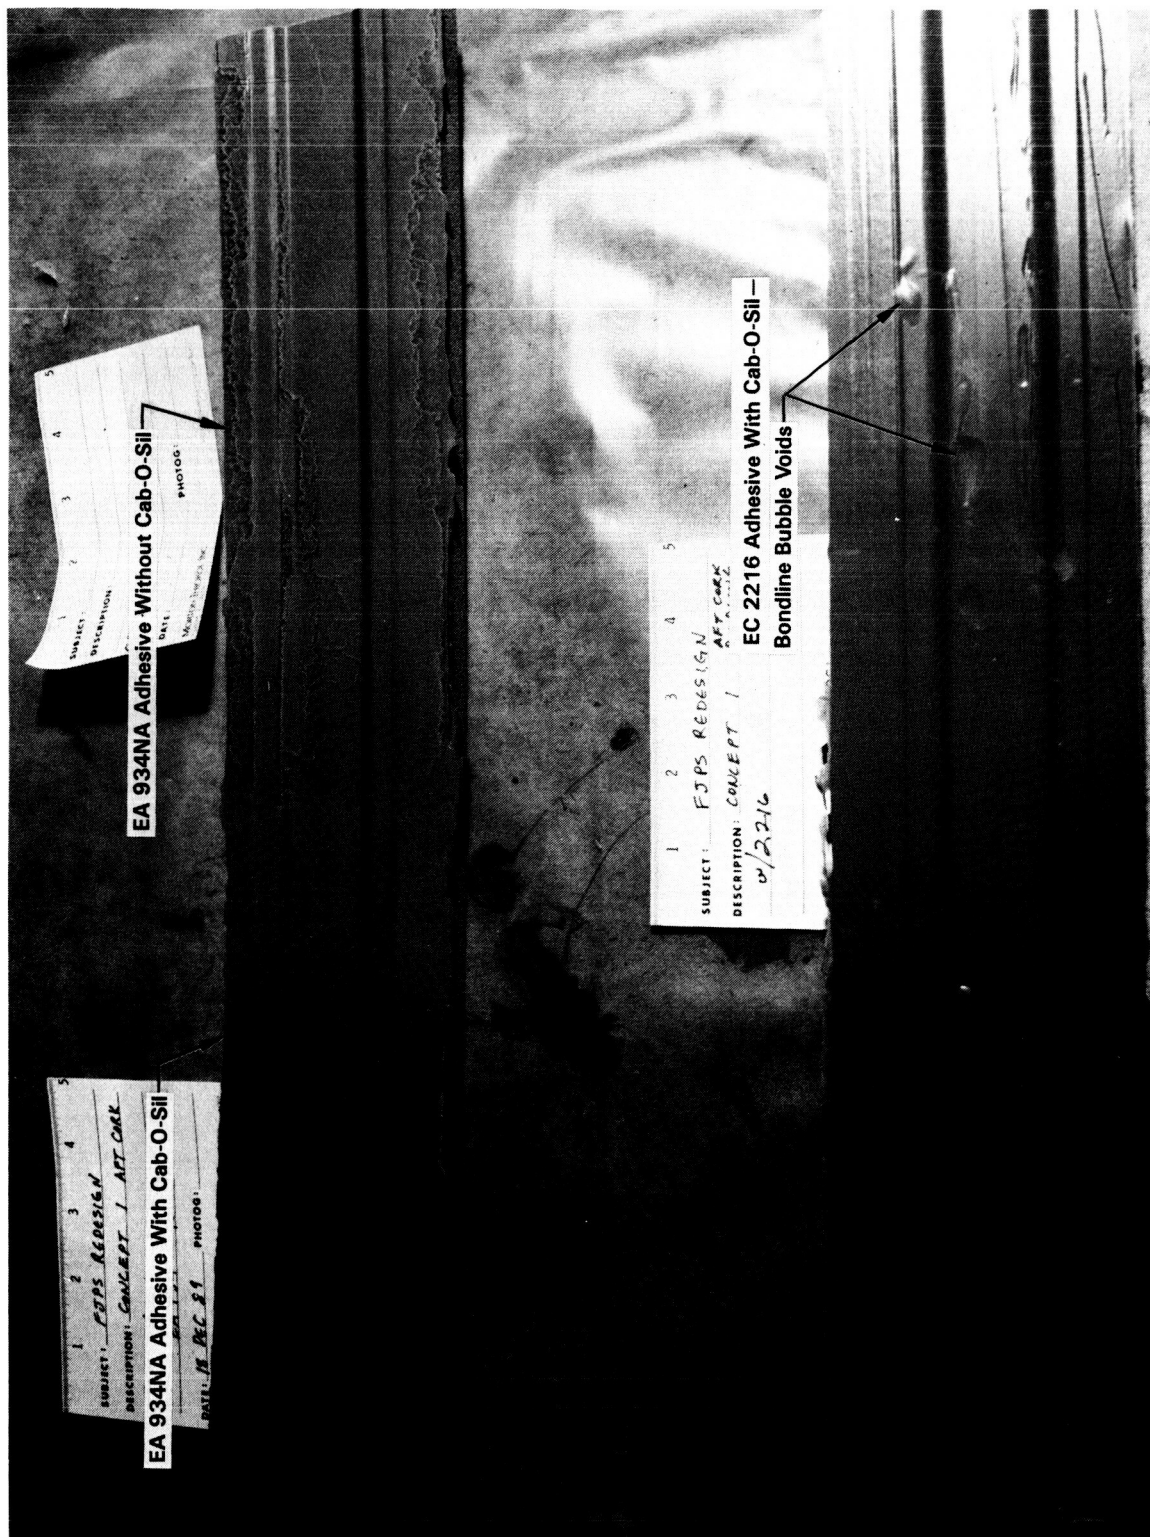
Figure 10. Concept 1 Aft Cork Band--Adhesive Bondline Comparison

Removal of the Concept 1 aft cork sections that were installed over Teflon[®] tape revealed bubbles in the cured EC 2216 adhesive. The EA 934NA adhesive with Cab-O-Sil bondline had a few small pits. The EA 934NA adhesive bondline had no visible voids and was thinner than the other two adhesive bondlines.

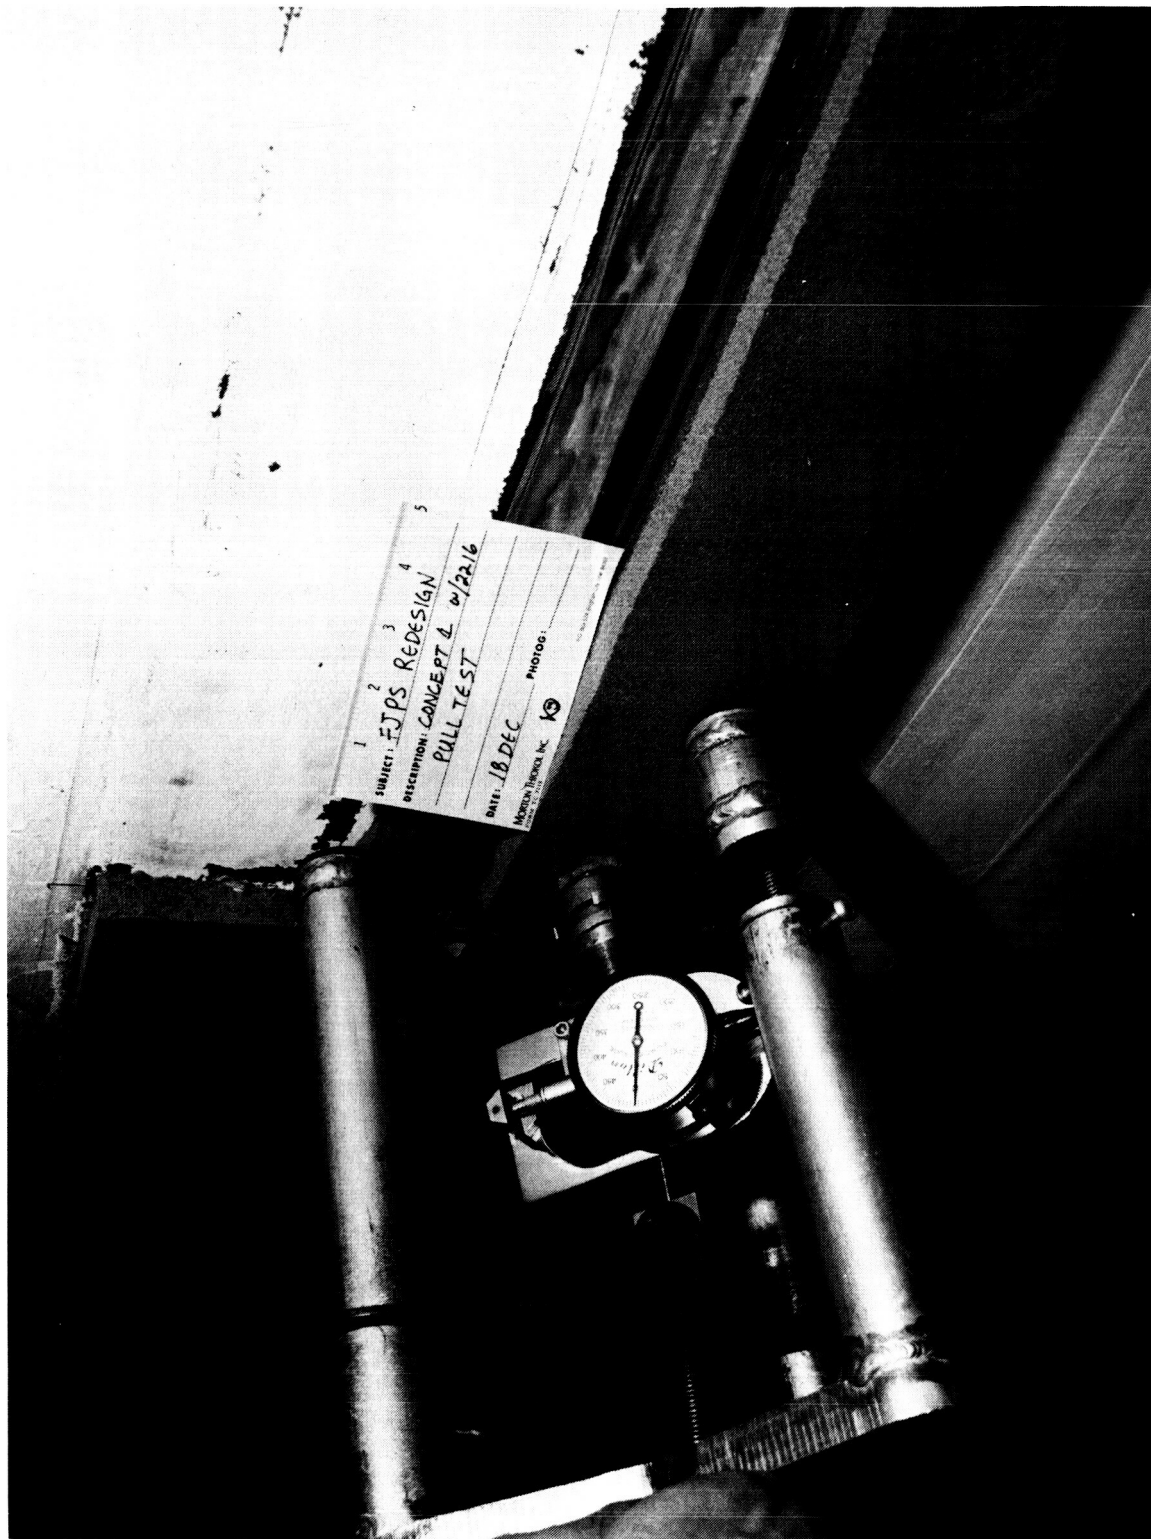
Pull Testing. Five days after the cork installation, pull testing was performed to determine the bondline integrity for cork sections that were installed directly to the case (Figure 11). Pull tests

Figure 11. Concept 1 Aft Cork Band--Typical Pull Test

for each adhesive were performed; the results are listed in Table 3. Two of the seven pull tests performed over the EA 934NA adhesive failed at the cork/case adhesive bondline, indicating that the pin retainer band surface may have been contaminated during installation. Cohesive cork failures in the other pull tests indicate adequate adhesion for each adhesive.

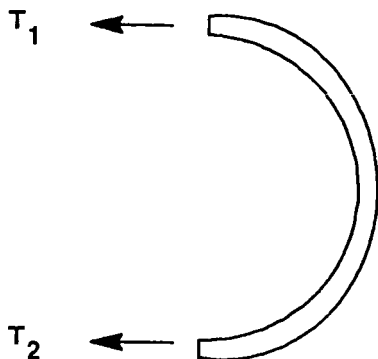
Consider a 180-deg section of one steel strapping band

T_1 location near tensioning tool

T_2 180 deg from tensioning tool

$T_1 > T_2$

$$T_2 = \frac{T_1}{e^{f\theta}} = \frac{700 \text{ lb}}{e^{(0.04)\pi}} = 617 \text{ lb, tension in band 180 deg from tensioning tool}$$

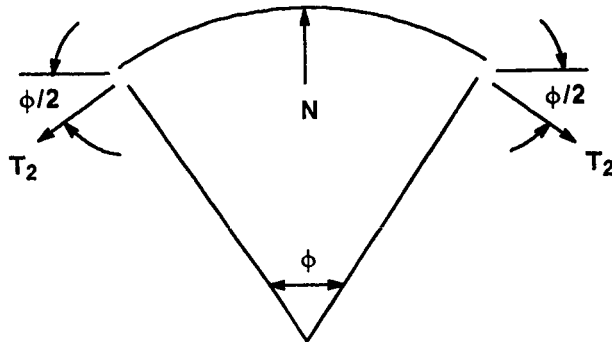
Radial force: consider a free body diagram of a 1-deg section at 180-deg

Assume band tension does not vary significantly over a 1-deg section
